Property Location: 123 Main Street - Anyplace, TX	Inspected By: Matthew Kenny	Insp Date: January 1, 2010
Client: John Smith	TREC License: #09997	Time: 12:30 PM

PROPERTY INSPECTION REPORT

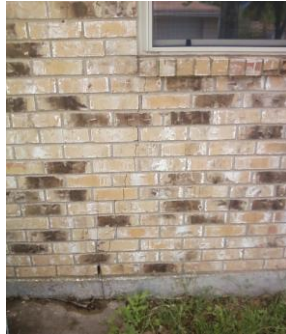
Photo 2

- 1. Type of foundation: Slab on grade
2. Crawl space: Yes No Adequately vented: Yes No
3. Indications of foundation movement: yes - see comments below
4. Post tensioned slab: Yes No Ends protected: Yes No
5. Comments (An opinion on performance is mandatory):
a. The foundation appears to be providing adequate support for the structure based on a limited visible observation.
b. Cracking of slab at northeast corner of house (See Photo 1)
c. Cracking of brick at north side of house - indication of vertical movement of veneer although crack did not visibly transfer through to foundation. (See Photo 2)

- 1. Weep holes provided (if masonry): [checked] Yes [] No
2. Comments:
a. See cover for exterior wall types.
b. Rotting wood evident at front of house at garage door jambs, front entry vestibule, and front eave. Recommend replacement. (See photo 7 and 8)
c. Cracking of brick at north side of house - indication of vertical movement of veneer although crack did not visibly transfer through to foundation. (See photo 2)
d. Cosmetic - drywall joint taping in sunroom has deteriorated and separated from wall.

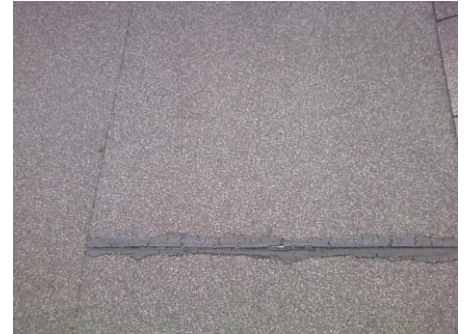
Photo 3

- 1. Type: Asphalt Shingle Metal Clay Other
2. Method used to inspect roof: Walking Viewed from ground Viewed from eave with ladder
3. Evidence of prior repairs: Roof appears to be recent. Roof vents appear to be added recently.
4. Appearance of flashings & penetrations: Acceptable In need of repair
5. Chimney cap / crown / flashing comments: no chimney
6. Comments:
a. Roof appeared to be recent and in good condition. Recommend re-sealing asphalt laps over sun room - evidence of cracking and separation. (See Photo 3)

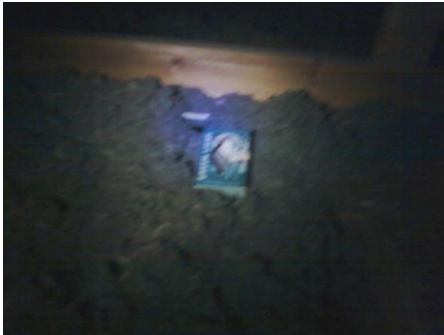
Photo 4

- a. Laundry room vent terminated in attic space. Exhaust vents should terminate to exterior of structure to avoid adding humidity / moisture to attic space.
b. Evidence of previous vermin activity. Could not locate any present vermin activity. (See photo 4)
c. Jack stud on roof rafter not attached. Recommend reattachment and evaluation by professional. (See photo 5)
d. Exposed romex wiring in attic laid loose and unprotected. Recommend affixing to structure or running through joists.
e. No insulation present above laundry room and adjacent closet. Recommend adding to reduce heat loss.

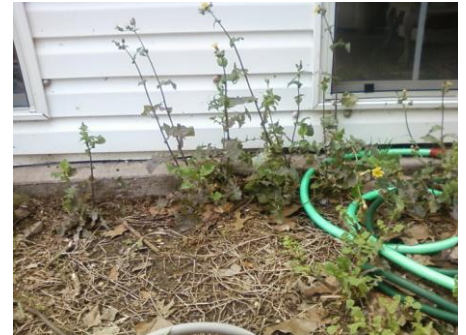
Photo 6

- 1. Sloped away from house: Yes No
2. Evidence of water penetration: No
3. Signs of soil movement: No
4. Comments:
a. Foundation at sunroom was not 6" above abutting grade. Grading also did not slope away from foundation. Potential water intrusion point. (See photo 6)

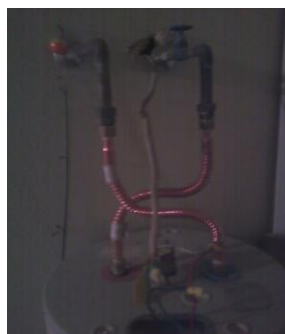
Photo 11

- 5. Safety pan present: [] Yes [x] No
6. Dielectric unions provided where required? [x] Yes [] No
7. Comments:
a. Water heater is newer (2006)
b. Water heaters located in garages are required to be 18" above floor. Viewed water heater to be resting on garage floor.
c. Exposed romex wiring not suitable for application. Wiring splices not in box. (See photo 11)

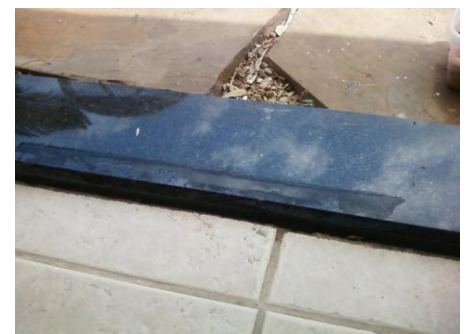
Photo 12

- 1. Exterior lock functions inspected [] Yes [checked] No
2. Garage door operation inspected [checked] Yes [] No
3. Comments:
a. Closet doors in 2 bedrooms were off tracks and in need of repair.
b. Exterior door sill of sunroom does not appear to be properly sealed. Potential water intrusion issue. (see photo 12)

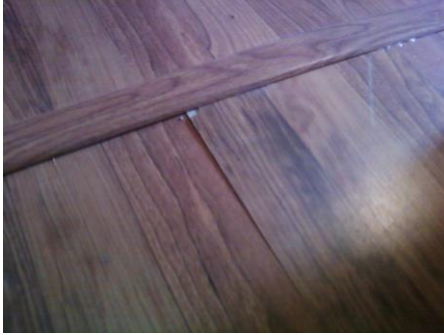
Photo 13

- 1. Comments:
a. Cosmetic - no transition strips provided between alternate floor types (e.g. wood to tile, bedrooms to closets, etc).
b. Cosmetic - wood flooring buckled in front of entry foyer at transition strip. (see photo 13)
c. Cosmetic - drywall joint tape in laundry room closet is separating from ceiling.

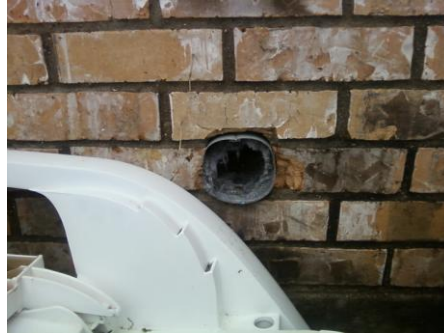
Photo 14

- 1. Comments:
 - a. Exterior vent was not covered. Possible intrusion of water and vermin. Recommend covering. (see photo 14)

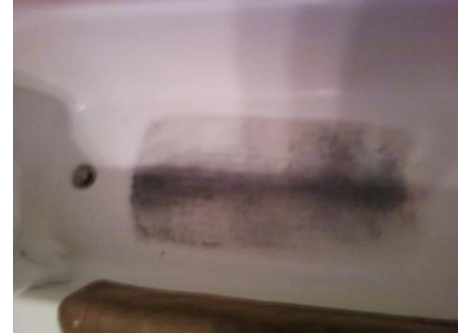
Photo 15

a. No additional comments.
b. Cosmetic - bathtubs exhibit extensive chipping and wear. (see photo 15)
